Glasheen Stream  
Freshwater Ecology Survey  
Version number 1  
14/11/2024

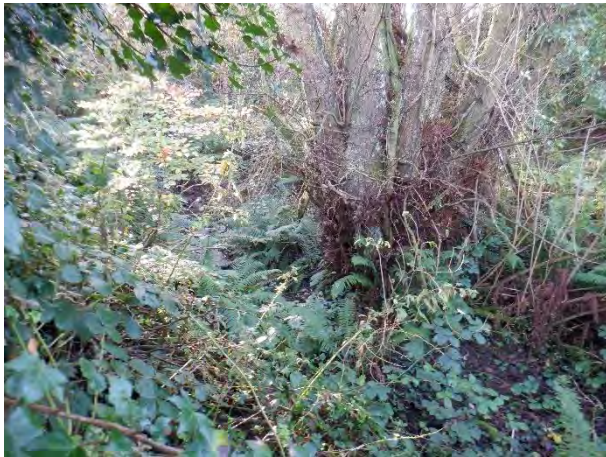
**Plate 4-1: Glasheen upstream of the cemetery close to its source.**

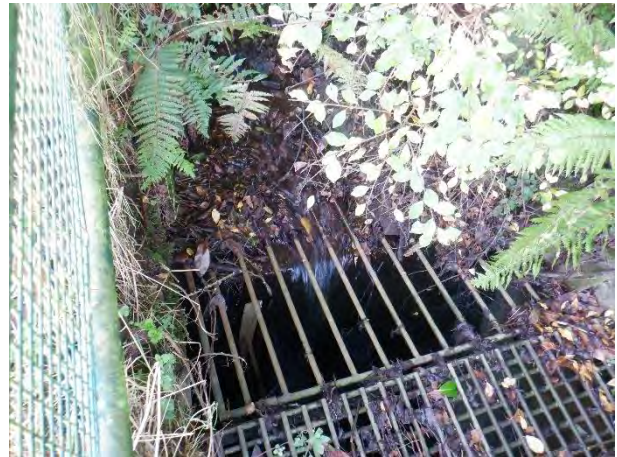
**Plate 4-2: Glasheen as it drops 1m down a concrete ledge and piped under the cemetery.**

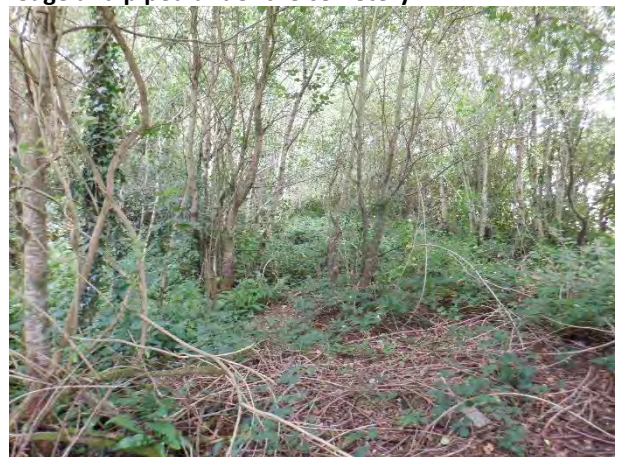
**Plate 4-4: Narrow woodland present between the Glasheen and St James's Cemetery serving as a good riparian habitat and wildlife corridor, however heavy littering is present.**

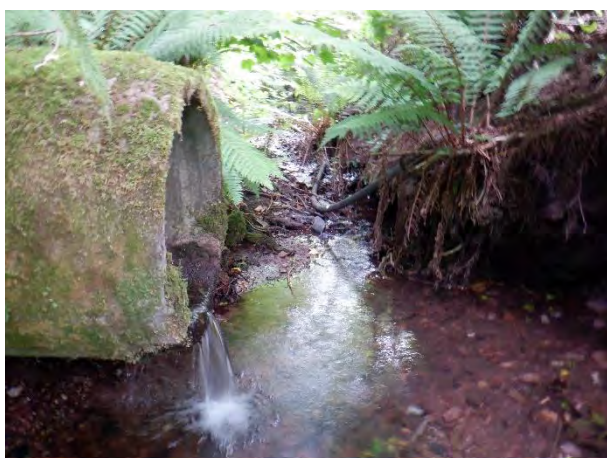
**Plate 4-5: Outfall of a small stream to the Glasheen which is piped under the cemetery. See Figure 1-2 for historic mapping of this channel.**

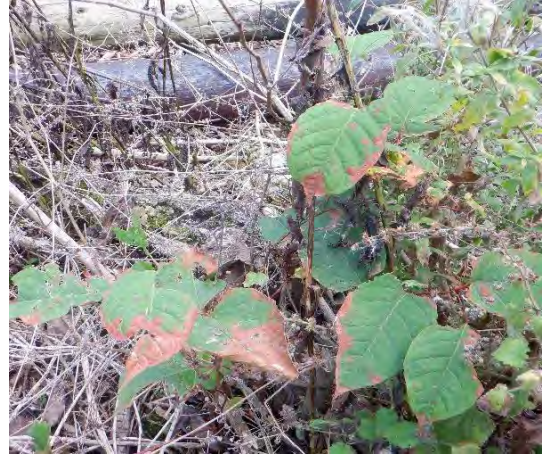
One third schedule invasive species was observed, **Japanese knotweed** (*Reynoutria japonica*), please see **Section 5** for further detail. Aquatic vegetation consisted of hemlock water-dropwort (*Oenanthe crocata*) and fool's watercress (*Apium nodiflorum*) growing along the margins.

**Plate 4-10: Japanese knotweed growing along the laneway at Ardarostig.**

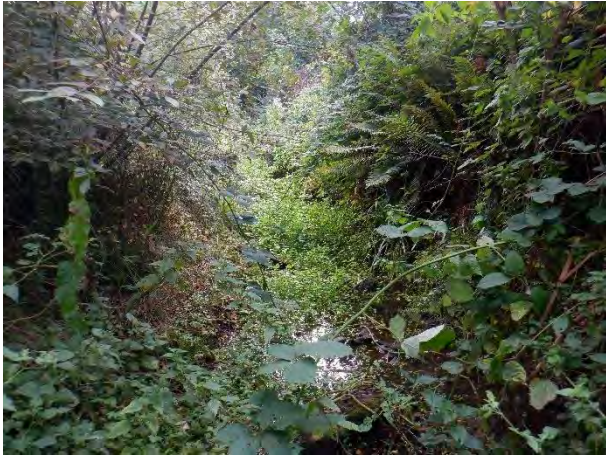
Plate 4-12: Glasheen at Site 3 facing upstream where channel is almost entirely covered with fool's watercress.

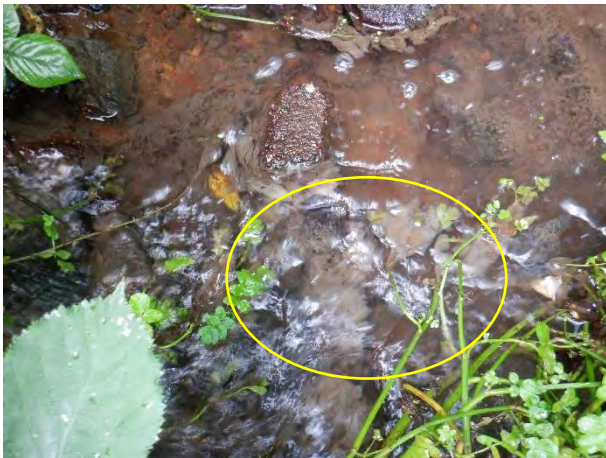
The kick sample showed very low macroinvertebrate diversity with only 8 taxa present. No sensitive or less sensitive taxa (Groups A or B) were present in the sample. One very tolerant (Group D) taxon was present and was also numerous, (*Asellus aquaticus*). Two most tolerant taxa (Group E) were also present but in low numbers (*Chironomus* and *Eistalis* spp.). Both these taxa are adapted for low oxygen conditions. The remainder of the sample was made of tolerant taxa (Group C) which were either in low numbers or common. As no Group A or B taxa were present and there were numerous *A. aquaticus* (Group D) a **Q2-3** was assigned indicating **Poor macroinvertebrate quality**. Please see **Appendix A** for full list of macroinvertebrates and abundances.

Plate 4-14: Example of sewage fungus growth at Site 3.

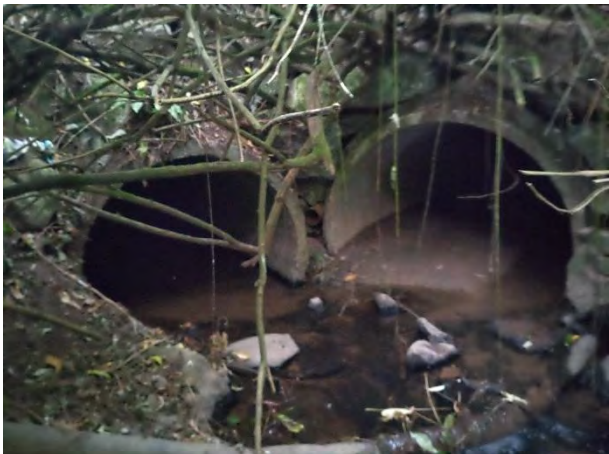
Plate 4-16: Pipe culvert on the left is the outfall of the Glasheen after it is diverted under the South Link Rd. Pipe on the right is an unknown piped stream.

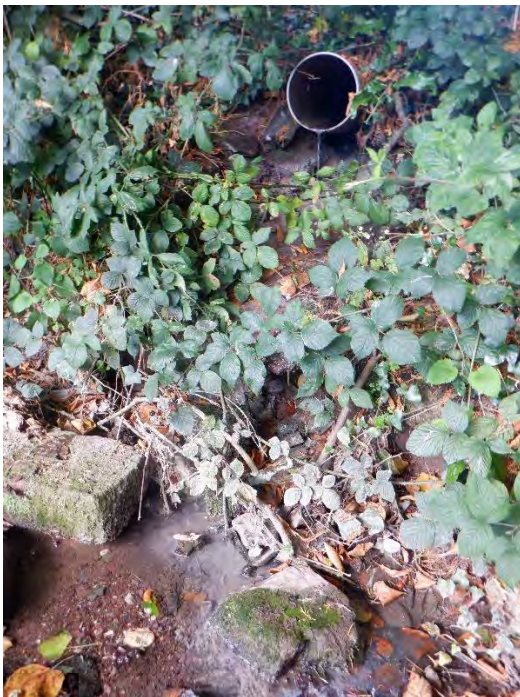
While most parameters were within normal range the oxygen levels declined further and were very low (26.9%, 2.67mg/l). The discoloured (grey) water, sewage fungus, low oxygen and foul odours all indicate a continuation of the organic pollution issue first noted at Site 3. The site was sampled on a dry day and the preceding day was also dry, therefore it was not expected that any CSO would be in operation. The pipes discharging water on the day of survey appears to be a misconnection discharging foul water directly to the Glasheen. The other pipes are also potentially misconnections and warrant investigation.

Plate 4-18: Outfall pipe discharging grey water on the day of survey. Grey water in the stream is visible in the bottom half of the photograph

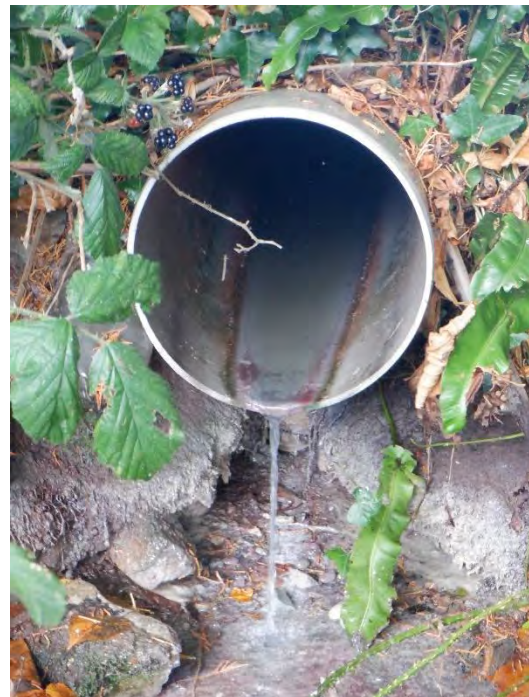
Plate 4-19: Close up of the pipe in previous image with sewage fungus visible around the outfall.

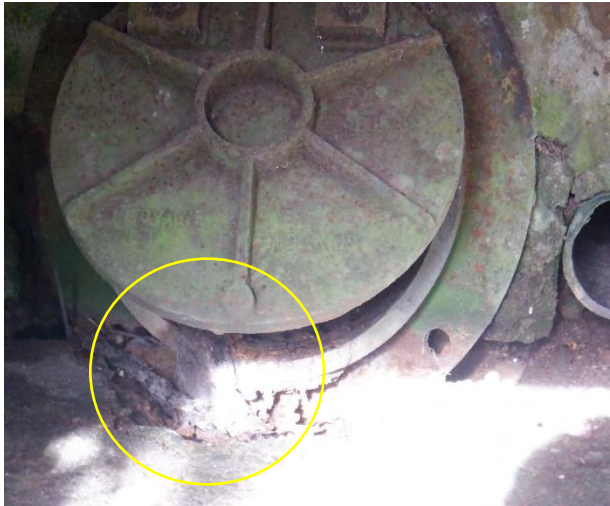
**Plate 4-20: Outfall with control valve. This was not active on day of survey but rags are visible in the pipe (yellow circle) indicating it discharges foul water.**

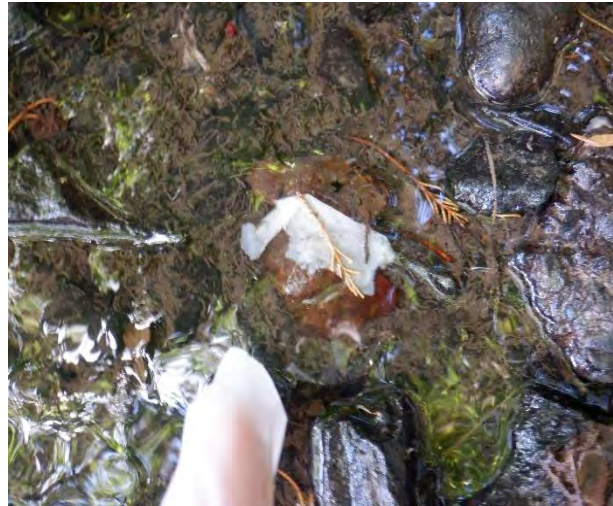
**Plate 4-21: Example of tissue on the stream substrate indicative of untreated discharges.**

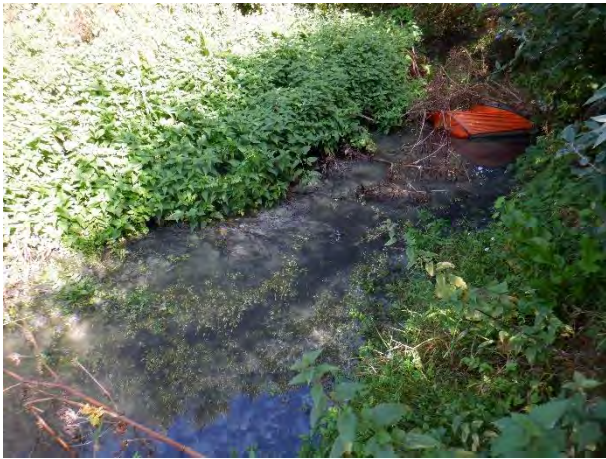
Plate 4-22: Glasheen between sites 4 & 5 where grey coloured water appears for the first time

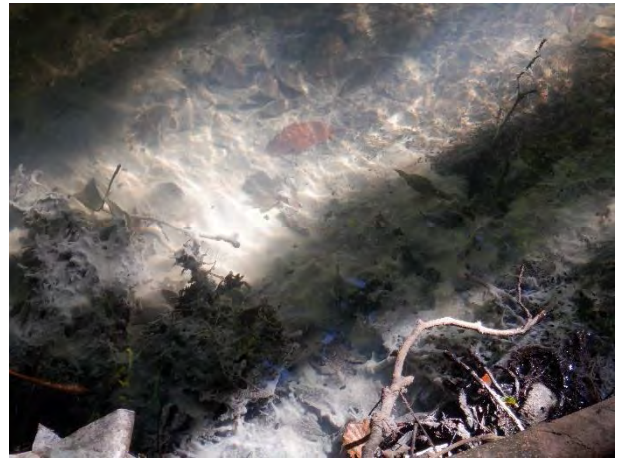
Plate 4-23: Example of the substrate with sewage fungus between sites 4 & 5.

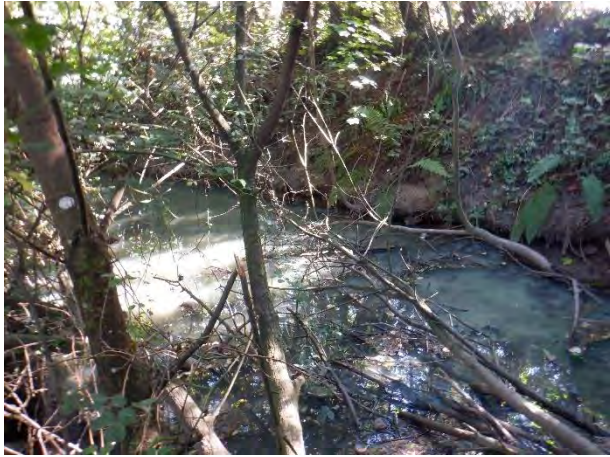
Dissolved oxygen levels plummeted at this site (4.2% 0.41mg/l) indicating very high anaerobic bacteria activity. Conductivity increased slightly to 581  $\mu\text{S}/\text{cm}$  where it was between 456- 486  $\mu\text{S}/\text{cm}$  at the upstream sites. The results indicate a further deterioration and gross organic pollution in the Glasheen.

Plate 4-26: Glasheen at Site 5.

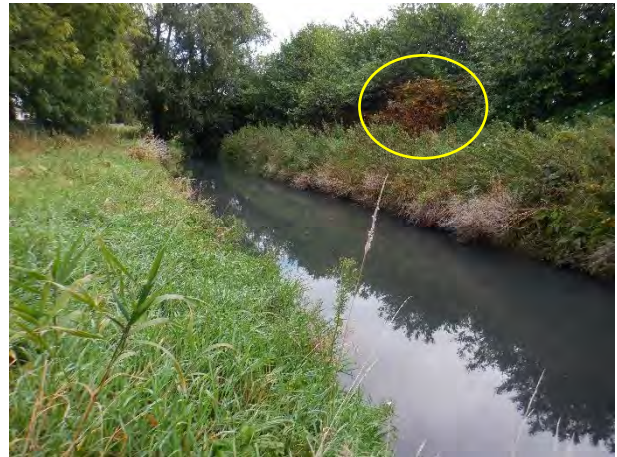
Instream aquatic vegetation was sparse with a small amount of starwort (*Callitriche* sp.). In a conversation with a parks worker they noted that some dredging did occur in 2024 which would explain the lack of aquatic vegetation. Filamentous green algae covered 30% of the silted substrate indicating enriched conditions. The water colour was very discoloured (grey) and a foul odour was again noticeable at this site. Wet wipes and small pieces of plastic were present instream all indicating untreated foul water discharging to the Glasheen.

Plate 4-29: Glasheen at Site 6 looking downstream. Note the very grey water. Stand of knotweed is highlighted in the yellow circle.

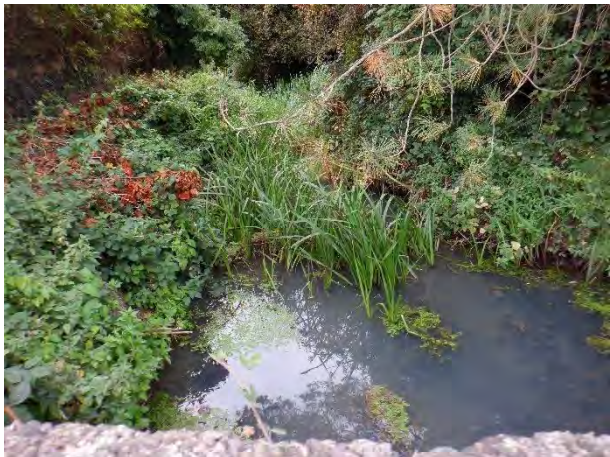
Plate 4-30: Glasheen at Glendale Road with grey water visible.

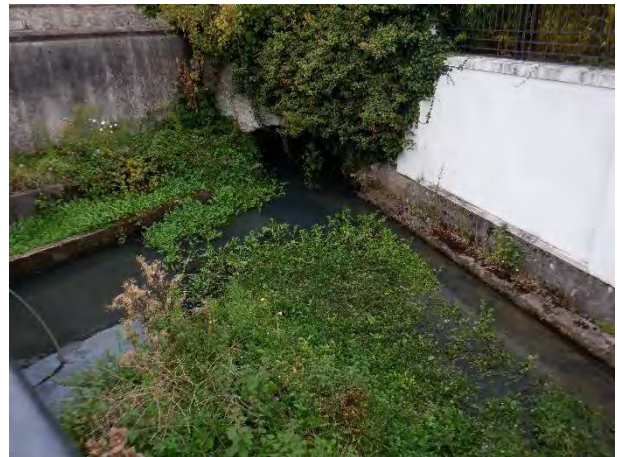
Plate 4-31: Glasheen Stream at Glasheen Road just before it passes along private housing estates. Grey water and sewage fungus present.

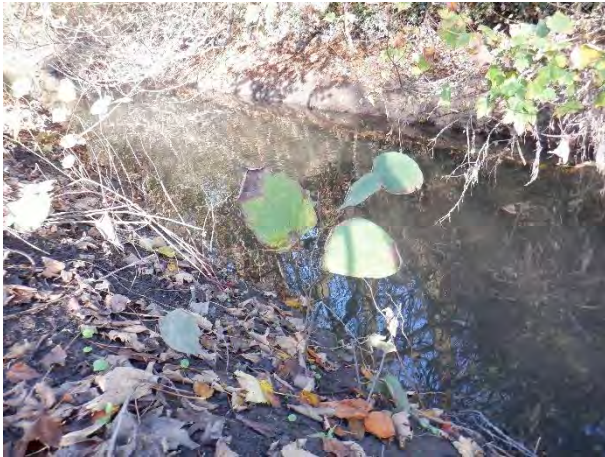
One third schedule invasive species was observed, **Japanese knotweed** (*Reynoutria japonica*), please see **Section 5** for further detail. Aquatic vegetation was sparse with some lesser duckweed (*Lemna. minor*), starwort (*Callitriche* sp.) and fool's watercress (*Apium nodiflorum*). The water was still discoloured (grey) and slightly turbid.

Plate 4-34: Example of Japanese knotweed growing along the left bank.

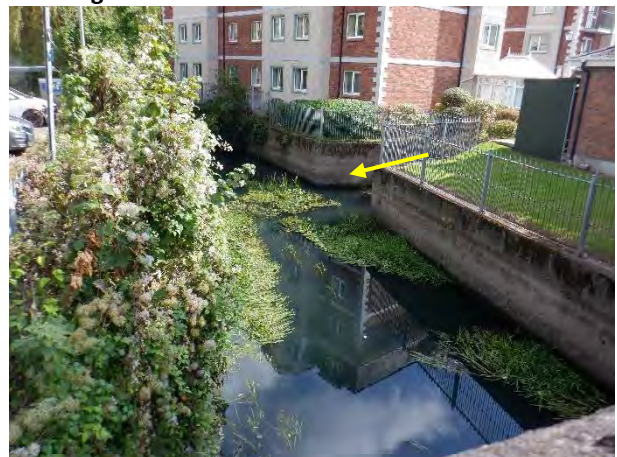
Plate 4-38: Grey water within the Curragheen just upstream of the Glasheen confluence (yellow arrow) indicating the water quality issues observed are not confined to the Glasheen.
